Initial Appraisal of the Neosho River Logjam

John Redmond Reservoir, Kansas

February 2005

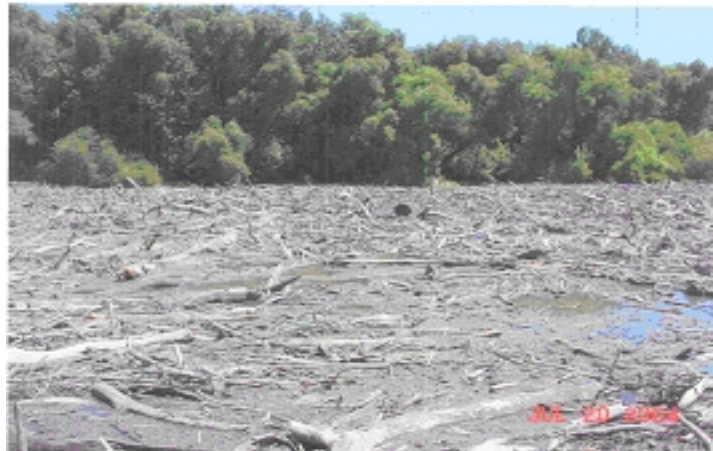
The severe ice storm in 2002 and higher than normal runoff in the spring of 2004 are generally believed to have caused enough additional debris to be added to the previous logjam so that in June 2004 the Jacobs Creek Landing boat ramp was unusable (see photo, courtesy of Jacobs Creek residents).

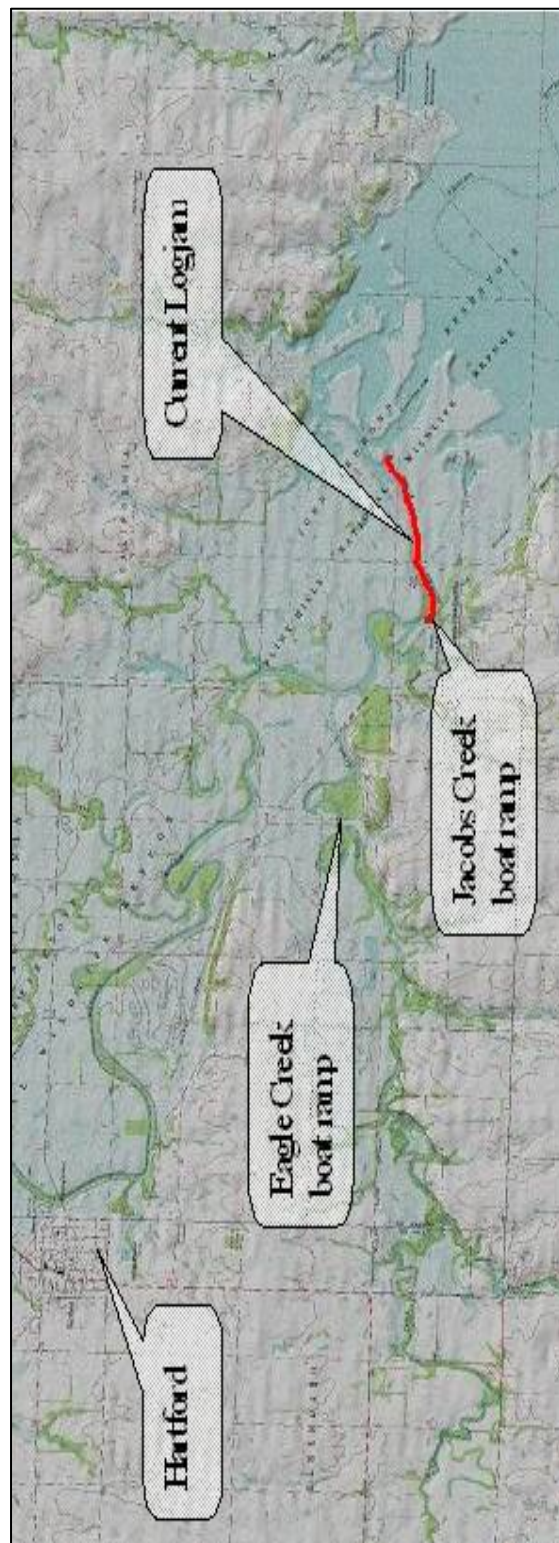
The illustration shows the Reservoir (in the lower right corner), Jacobs Creek Landing (on the south side of the Neosho River toward the center of the image), Eagle Creek (running from the lower left corner toward the center of the image), and the Neosho River (flowing from the northwest as it passes Hartford). The locations of logjams at various times are shown on subsequent illustrations. The initial logjam, often referred to as the “plug” locally, comprised the first 500 feet of the downstream end of the current logjam shown in the picture to the right.
